**NAUGATUCK RIVER BASIN  
NAUGATUCK, CONNECTICUT**

**MULBERRY RESERVOIR DAM  
CT 00130**

**PHASE I INSPECTION REPORT  
NATIONAL DAM INSPECTION PROGRAM**

**JANUARY 1980**

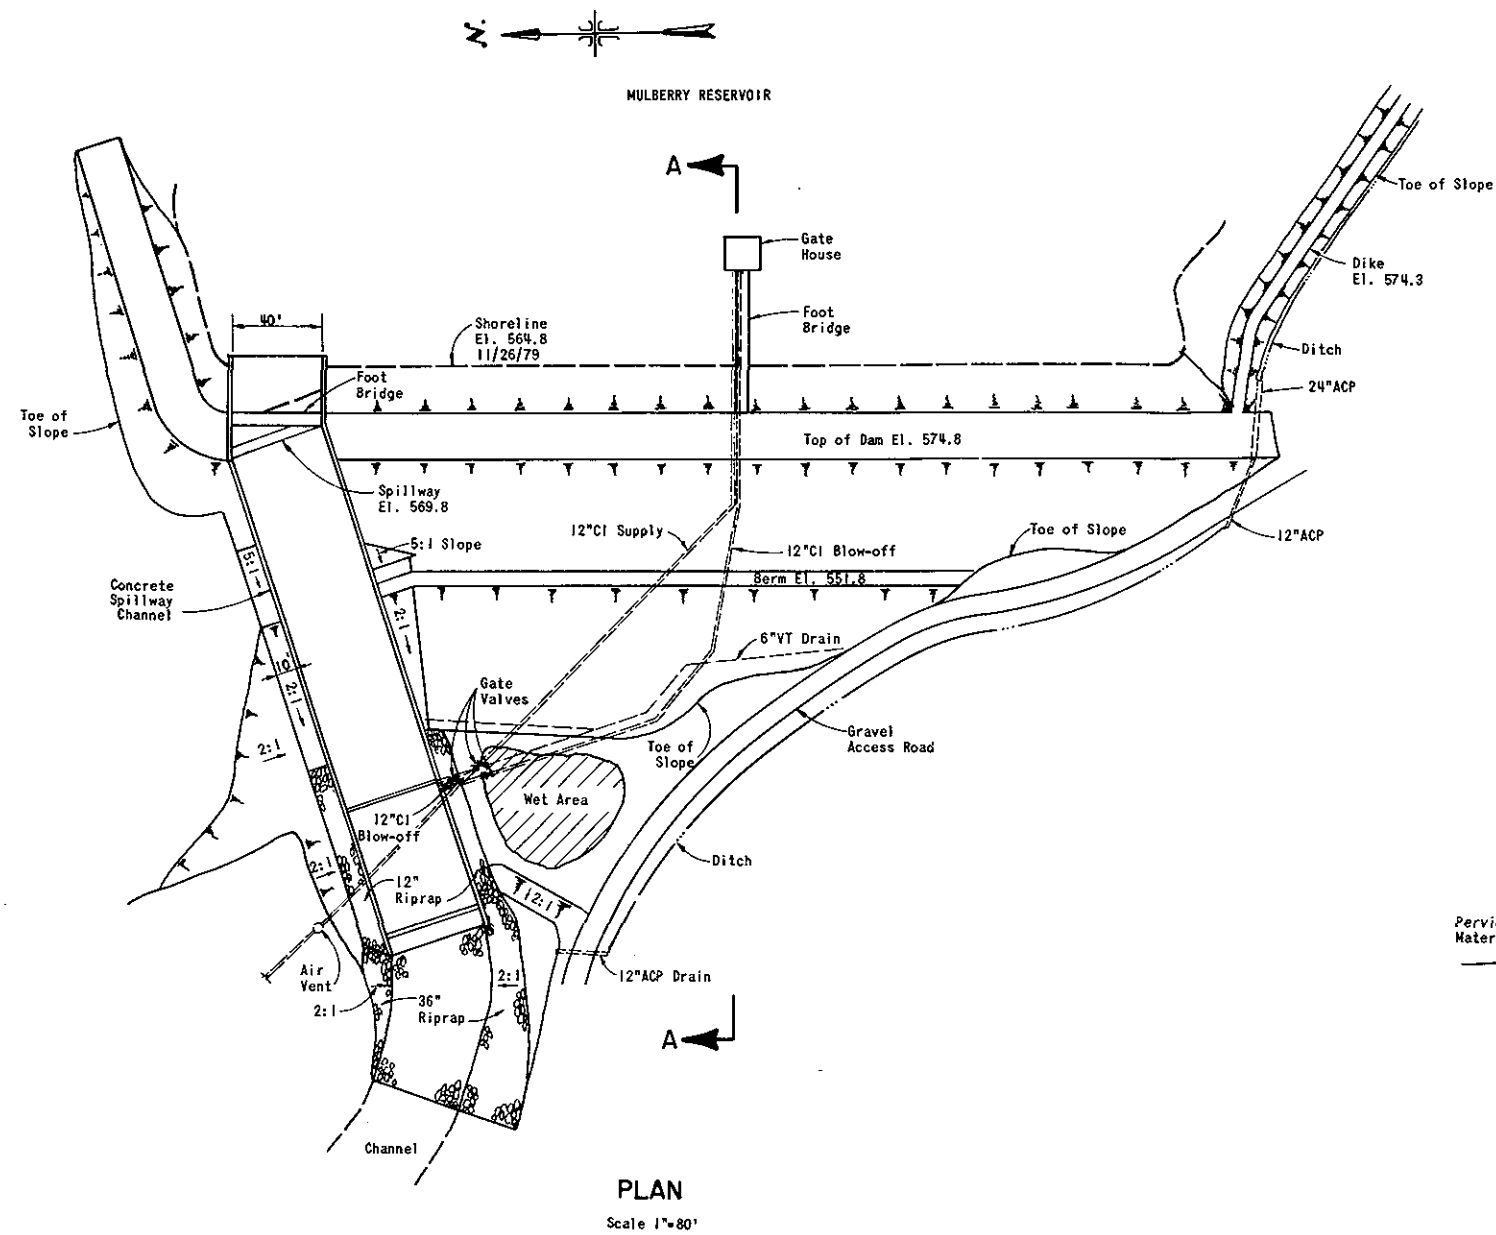
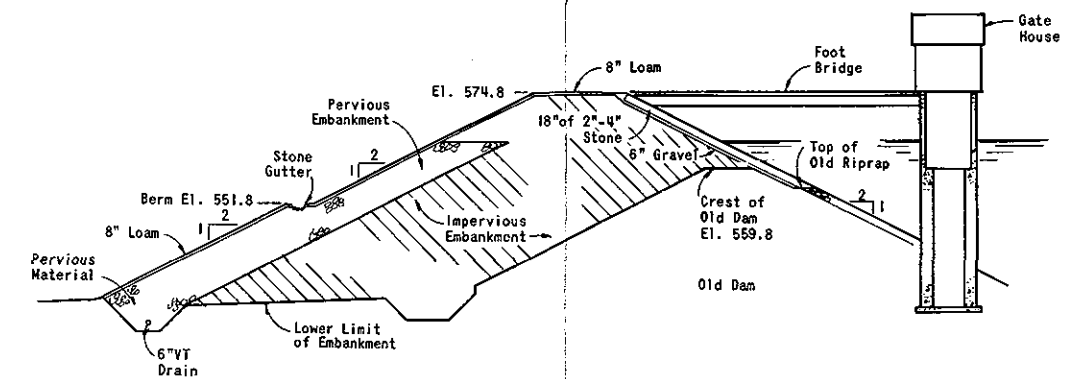
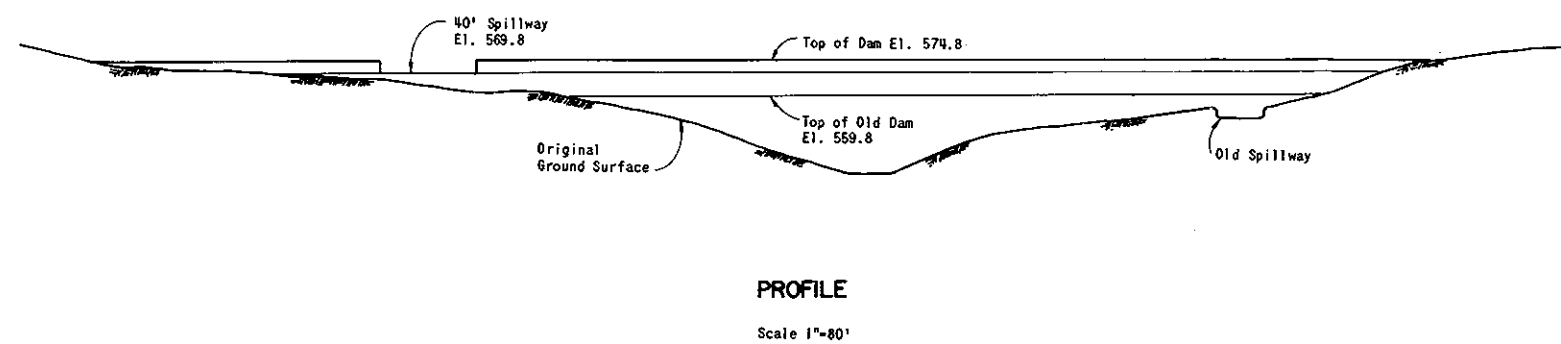
FIGURE 2

Field inspections and surveys revealed that the dam was constructed substantially as shown on the plans. The dike which forms a diversion channel and the pipe installed at the left end of the dam (See Figure 2, Appendix B) to divert an area of undesirable water quality away from the reservoir are not shown on the construction plans.

There are no indications of instability along the edges of the reservoir in the vicinity of the dam. At the left abutment a small dike forms a channel for diversion of a drainage area with poor water quality away from the reservoir and into a 24-inch pipe with an invert elevation of 571.2 or 1.4 feet above spillway level. The pipe passes through the dam and exits to the ditch on the left of the gravel access road as a 12-inch diameter pipe (See Figure 2, Appendix B).
